Welsh Streets, Princes Park, Liverpool

Building Survey Report

12,14,16 Kelvin Grove

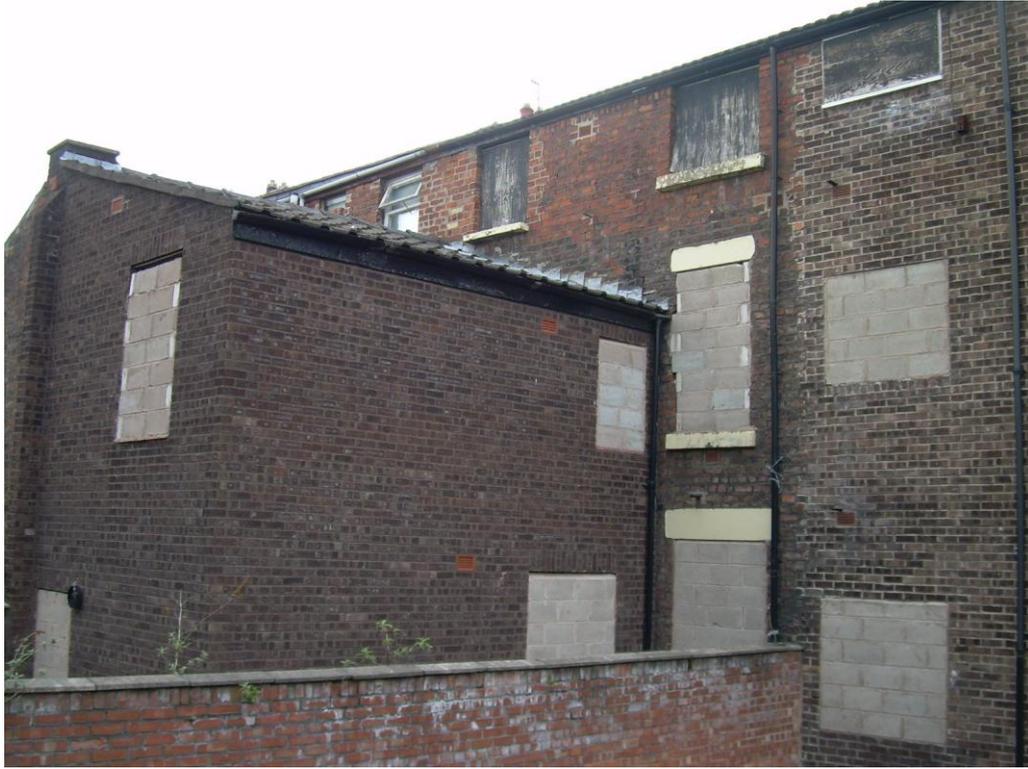
Rear elevation showing part re-built outrigger to No 12.

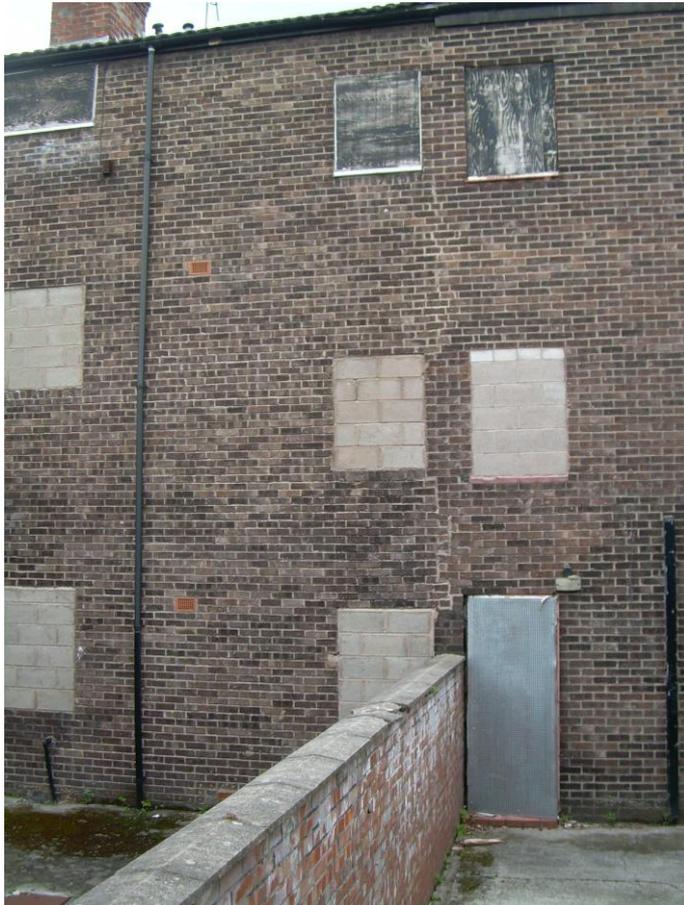
| 2.2.2 | Rear main elevation – in good overall condition having largely been rebuilt in the fairly recent past. | |

Main rear elevation.

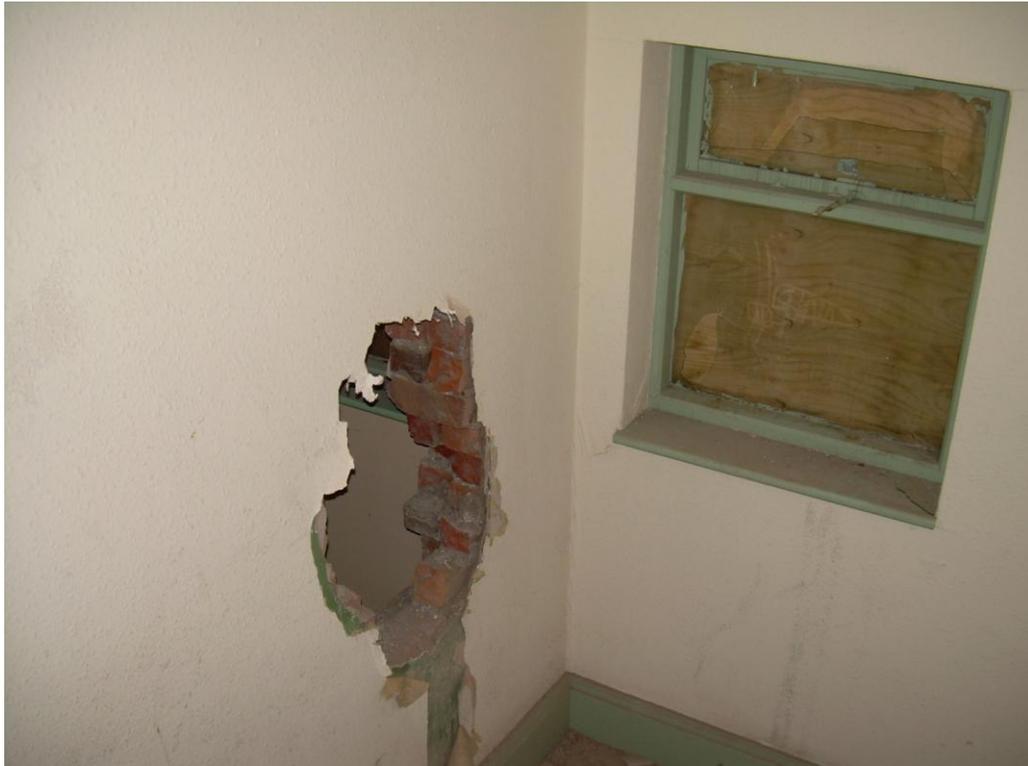
2.6.2 Vandals have also broken openings in the party walls in the rear stairwells, linking all of the units and no 18 at the landing level between first and second floors. This will clearly require reinstatement. £1000.00

Openings broken in party walls.

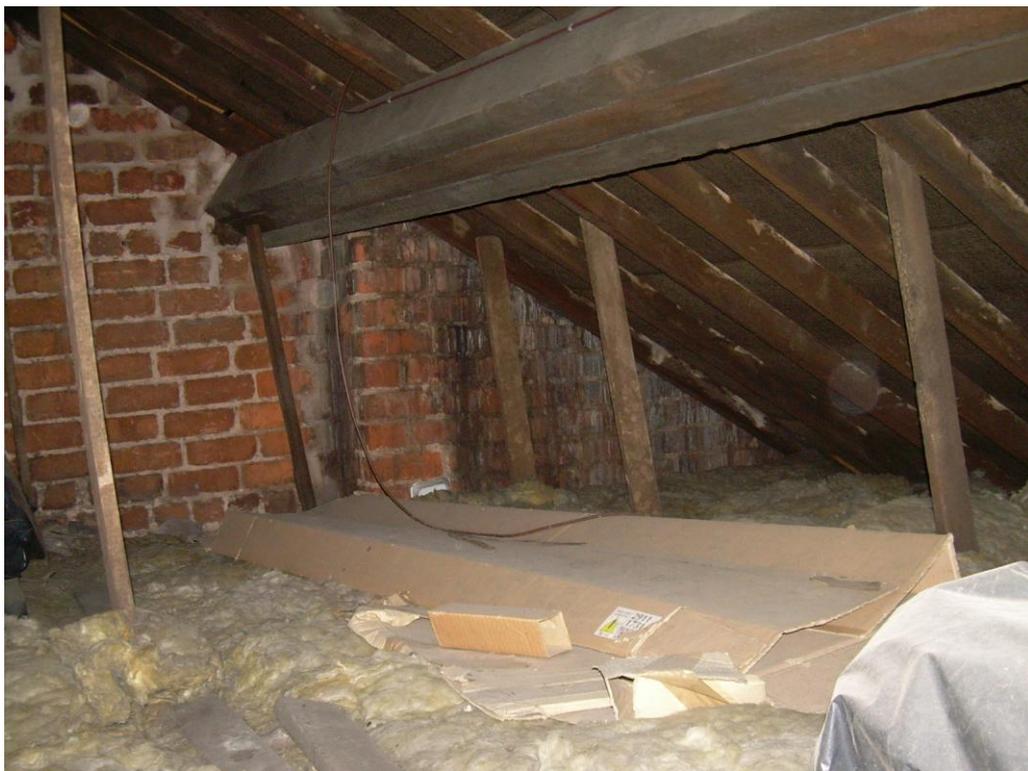
| 2.15.1 | Blown mineral wool insulation has been provided within the roof voids and this should be replaced with 250mm insulation to meet current standards. Cost includes suitable insulation to the sloping ceiling sections not accessible from within the roof voids. Fully sealed and insulated loft traps should be provided. | £1800.00 |

Typical roof roof with quilt insulation

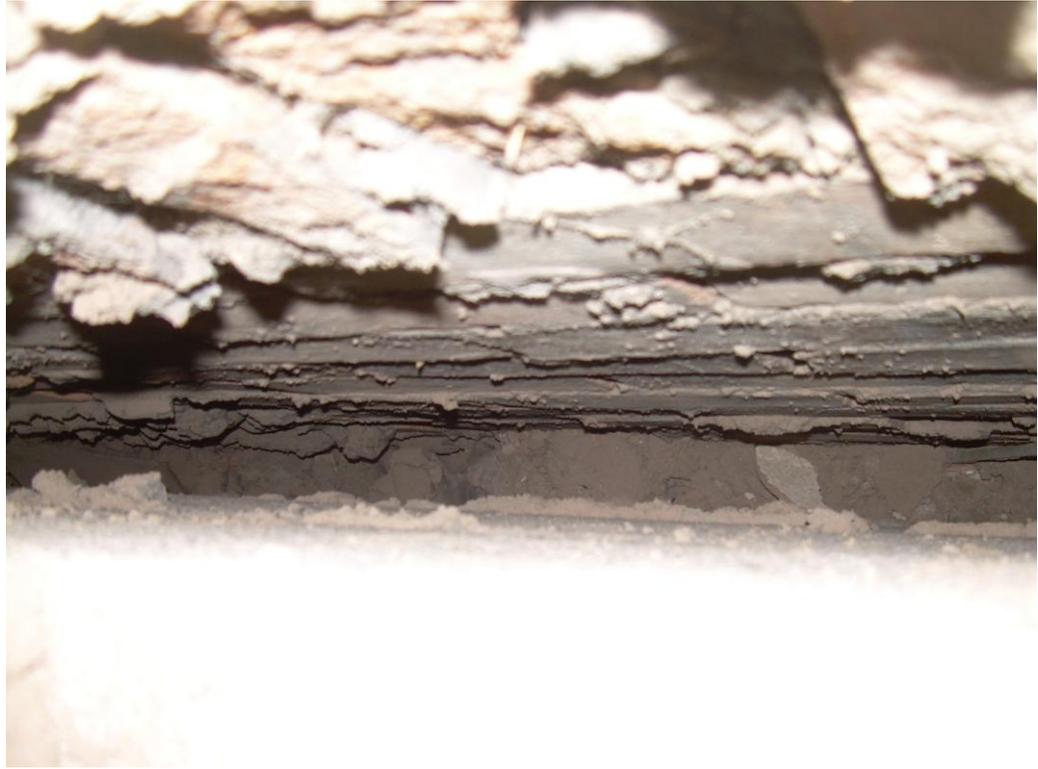
View down rear wall cavity – blocked with mortar

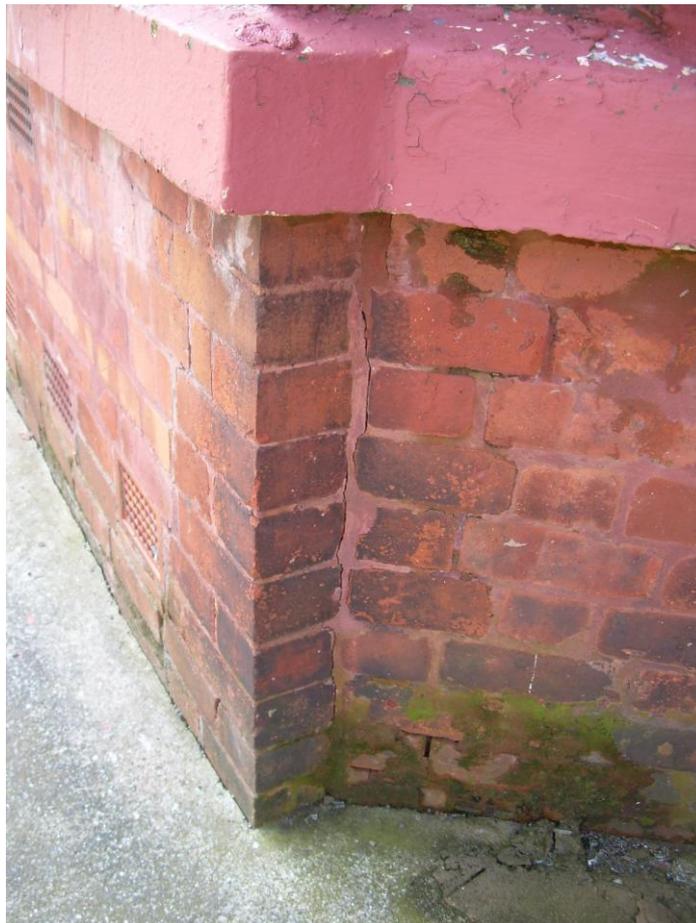
| 2.2.1 | The front elevation has been re-pointed in the past. Local re-pointing is required, particularly at low level where moss and algae growth is also visible. The front elevation has a marginal lean away from the street and there are vertical cracks to the external corner of the bay windows to all units, most marked to no.16. Allowance include for crack repairs. | £1000.00 |

There is vertical cracking to the external corners of the front bay windows, requiring repair.

Cracking to corners of front bay windows.

2.16.2	Having examined other buildings in the locality, there seems to be a widespread issue with foundation movement. However, without ascertaining the precise cause of this mechanism, we are unable to reach a formal conclusion at this stage. It is therefore recommended that some form of ground investigation is instigated including a structural engineer's input, in order to fully determine the reasons for the movement and appropriate remedial measures. At this stage we have allowed a provisional sum for foundation stabilisation.	£110,000.00
--------	--	-------------
