**Welsh Streets, Princes Park, Liverpool**

**Building Survey Report**

**38 Kelvin Grove**

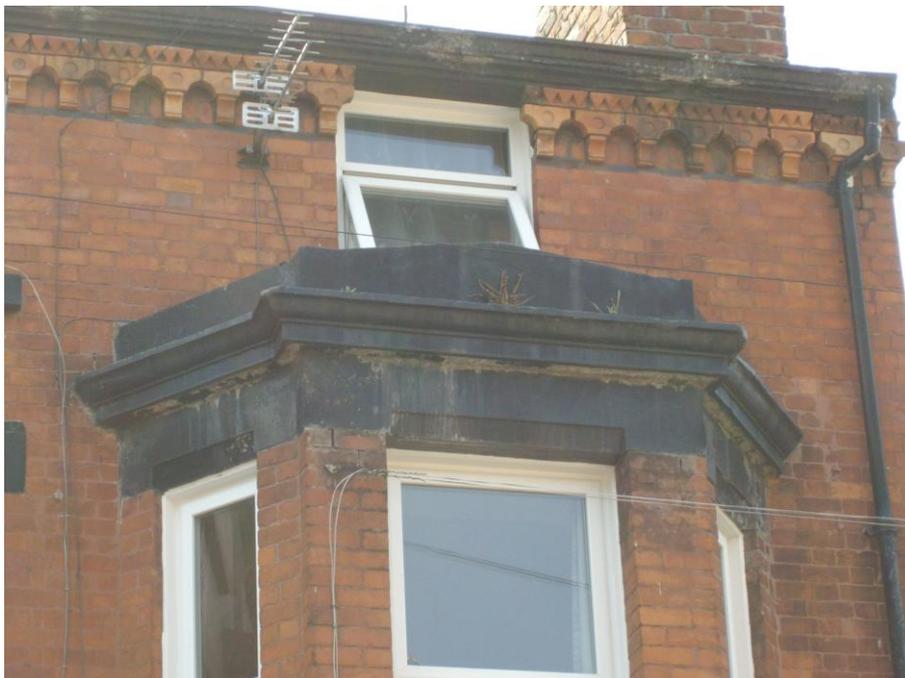
2.1.4	The metal and plastic gutters to the front and rear elevations are leaking at joint positions and there are some missing pipework sections, requiring attention.	£2100.00
<b>2.2</b>	<b>Elevations</b>

Upper areas of front elevation showing gutter leaks, water staining and vegetation.

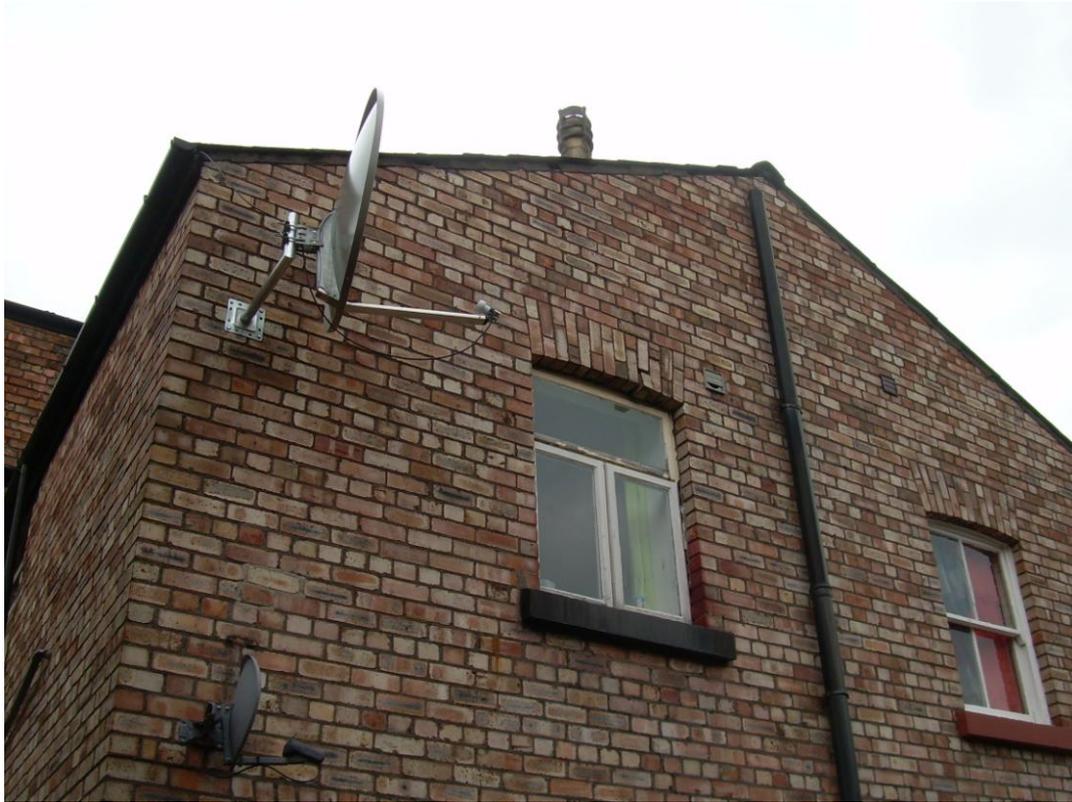
2.16.1	
<p>The rear ground floor is the main area showing evidence of movement, downward and left, toward the rear. We assume that this mechanism has resulted in the re-building of the rear wing at some point</p>	
<p>We have allowed a provisional sum for foundation stabilisation.</p>

Rear wing rear gable – replacement structure

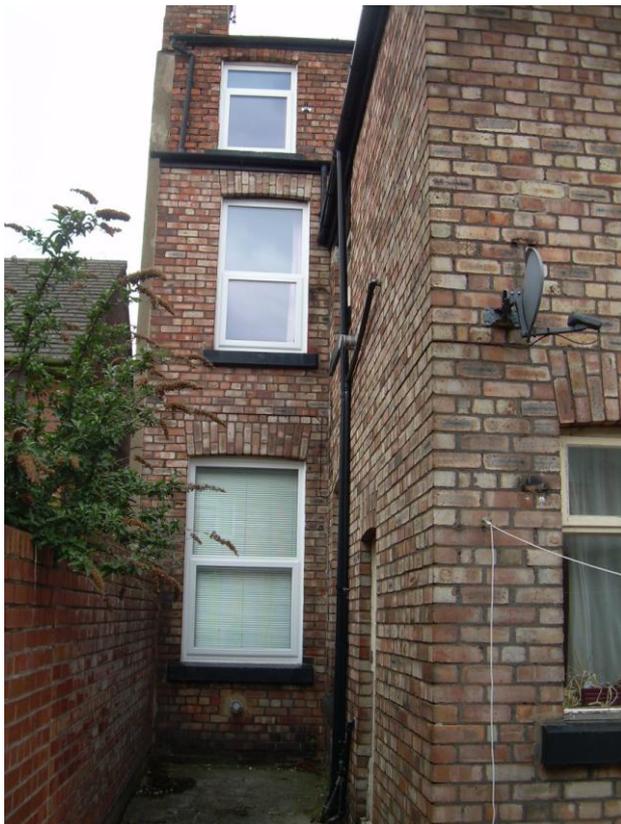
However, the outer walls of the rear wing and part of the rear elevation have been re-built as some point c. 50 years ago in solid 340mm brickwork.

Part re-built rear elevation.

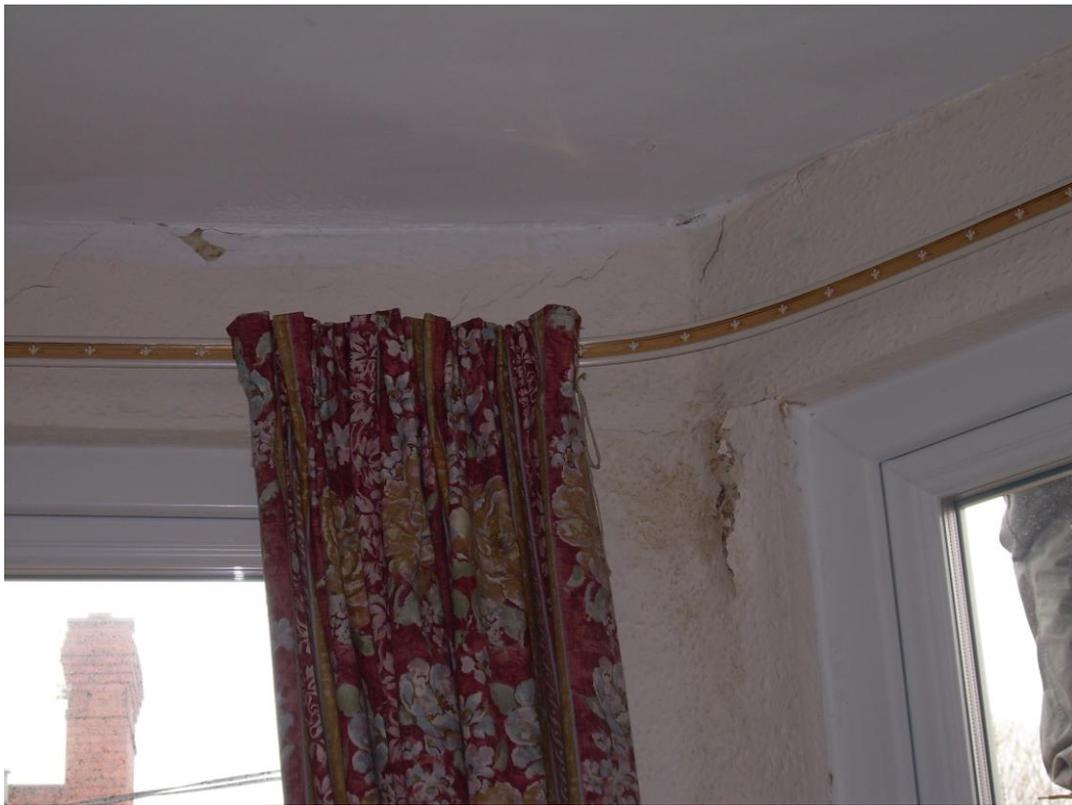
2.2.2	There is some minor cracking internally at the junction between the front elevation and the bay windows, with evidence internally at these positions. Allowance for crack repair.	£900.00

Damp stains and cracks in front bay at first floor.

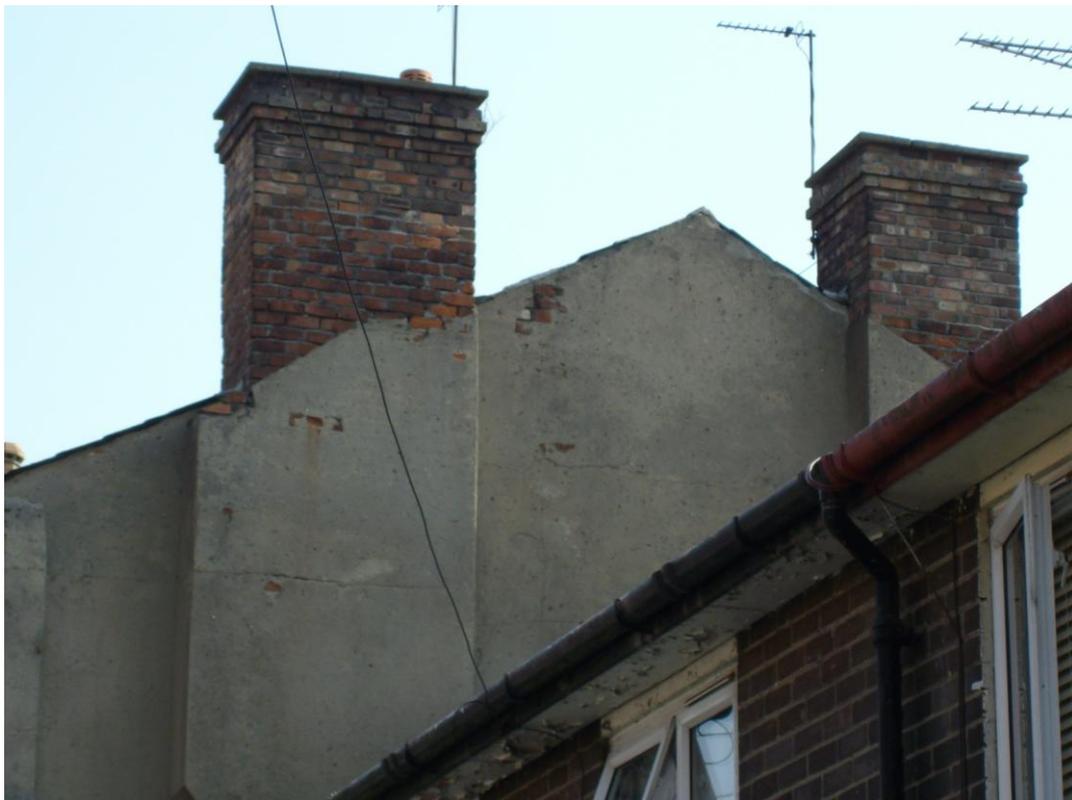
2.2.3	The right hand gable elevation suffers from penetrating dampness. The render gable should ideally be rendered and possibly insulated externally. The more modern wing elevations are generally in good condition.	£12000.00

Poor condition of render to gable.

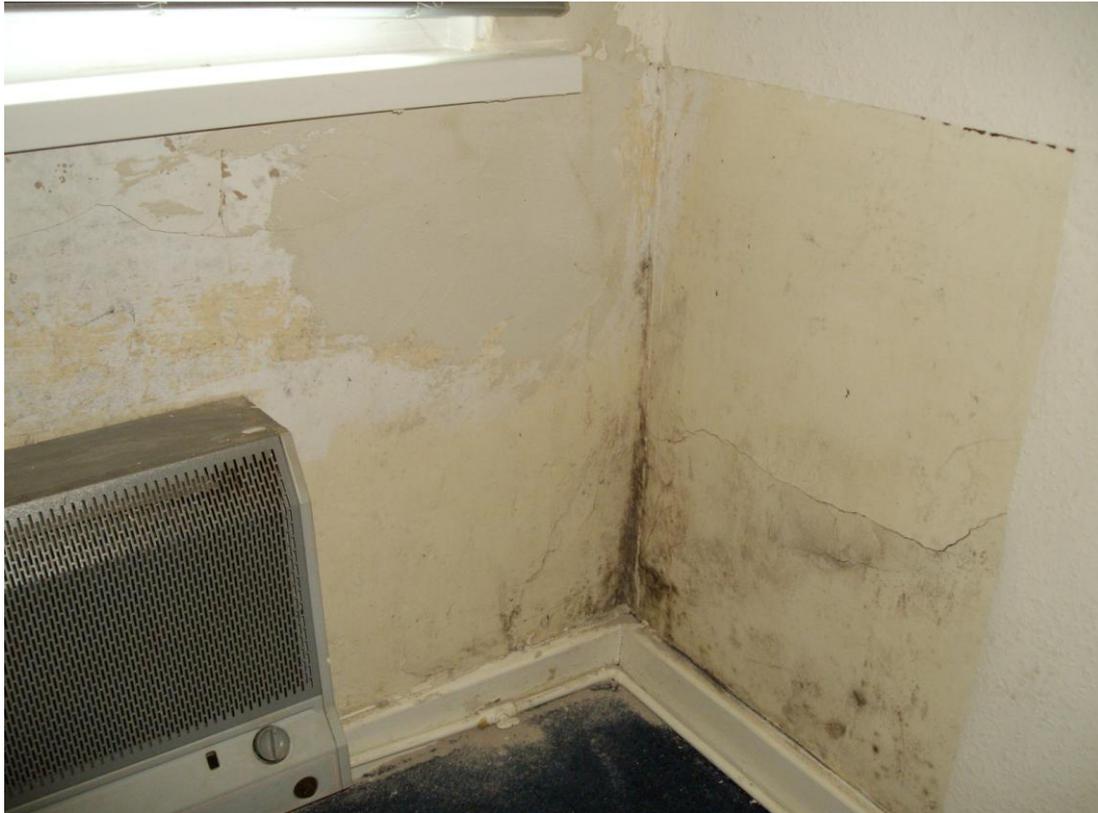
2.17.1	£3000.00
<p>High moisture meter readings were encountered within the ground floor both within flat one and in the common areas. Upper floor flats appear to be affected by driven rain penetration through the right hand gable wall.</p>	
<p>There is also widespread evidence of severe condensation problems and associated mould growth. Heating, insulation and ventilation levels all must be improved to alleviate this problem.</p>

Dampness and mould growth in ground floor flat – rear.

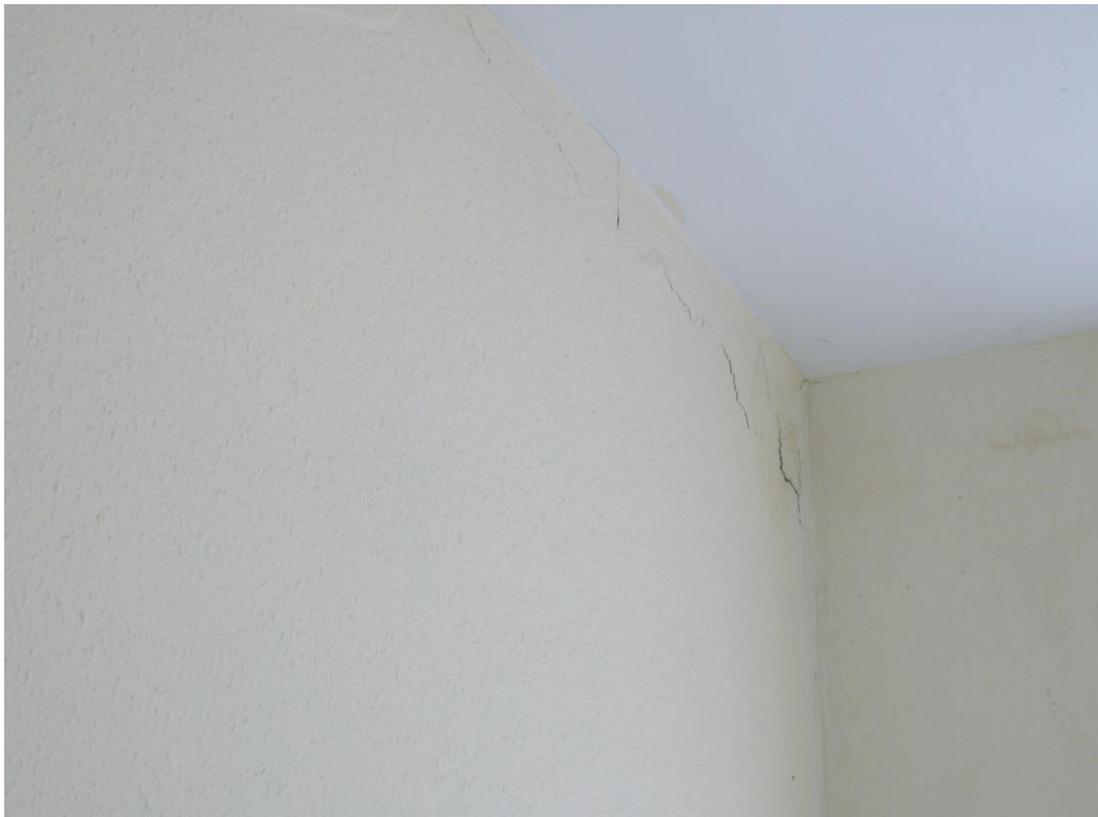
Cracks in rear stairwell at second floor, party with No 40.
