Welsh Streets, Princes Park, Liverpool

Building Survey Report

6/8 Kelvin Grove

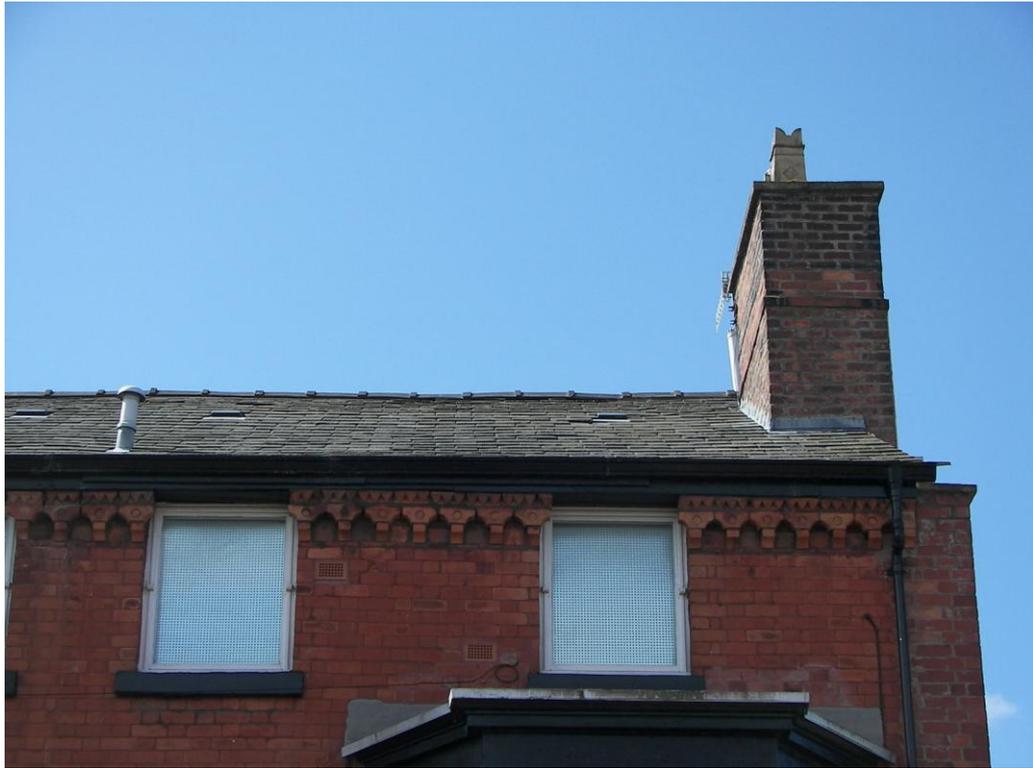
2.1.2 The roof coverings appeared in fair condition generally with no current water penetration although this has occurred in isolated areas in the past. The ridge to 6 Kelvin Grove was uneven. Isolated immediate maintenance is therefore required including refixing and £14,000.00

Typical roof condition

Estimated cost (£)
	repointing the ridge tiles and the dislodged undercloak to the rear right hand gable verge. However, provision of a 30 year life and also upgrading of the roof insulation to the sloping soffits will necessitate complete renewal of the roof coverings including reglazing the rooflight to the rear slope of 8 Kelvin Grove which was boarded over.

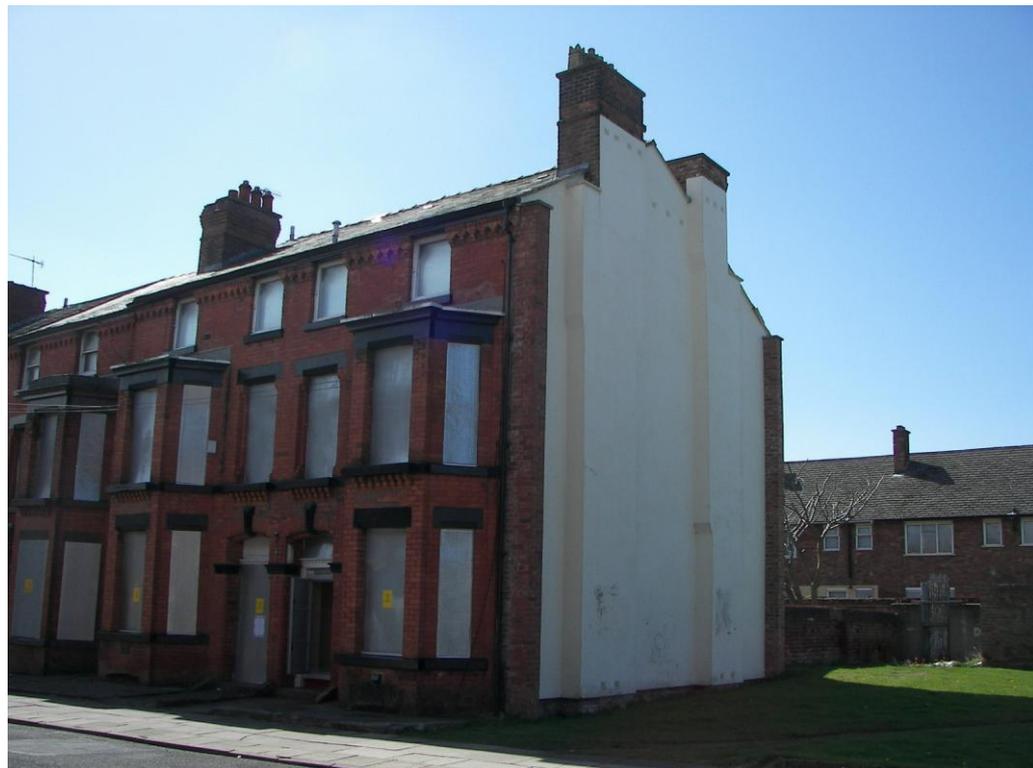
2.1.5	The missing soil and vent pipes at the rear require reinstatement.	£1,100.00
2.2	Elevations	
2.2.1	The front elevation has been repointed (and possibly grit blasted to remove paint) in the past. Patch repointing is required, particularly at low level.	£600.00

Front and left hand gable elevations

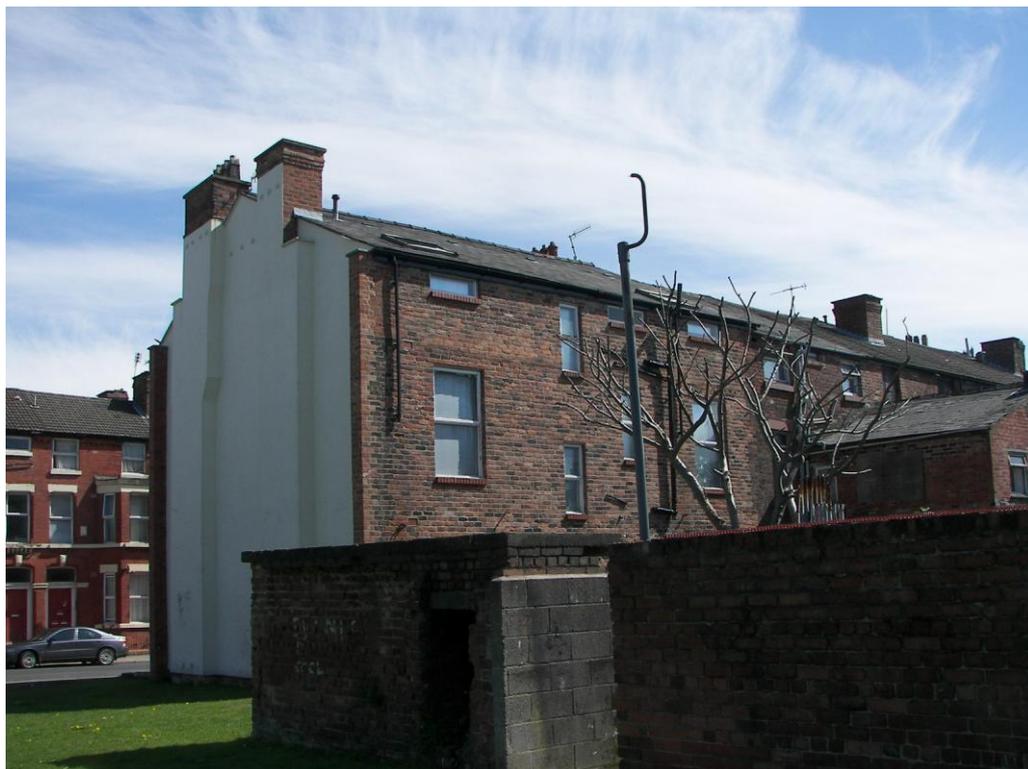
2.2.3	Rear main elevation – in good condition having been repointed in the fairly recent past.	-
2.2.4	External joinery – generally casements and sashes have been removed and openings protected by steel grilles or shutters. In order to provide a 30 year life we recommend replacement of all external joinery incorporating double glazed units. Doors to front and rear also require replacement.	£19,700.00

Rear elevation and roof

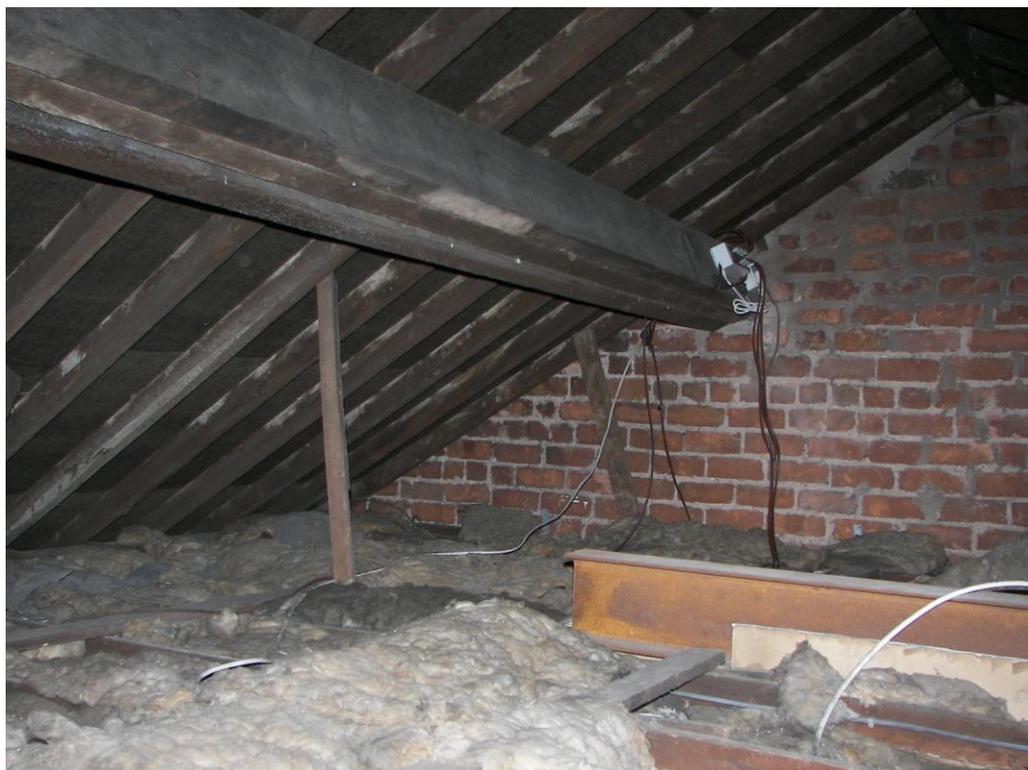
2.4.1	The roof voids were well ventilated and there was no obvious sign of penetrating dampness or beetle, as far as could be ascertained from the loft access hatch positions. However as close access to all timbers was not possible we recommend an allowance for timber treatment.	£600.00
-------	---	---------

Typical loft condition

2.15.1 Only 75mm fibreglass insulation has been provided within the roof voids and this should be replaced with 250mm insulation to meet current standards. Cost includes suitable insulation to the sloping ceiling sections not accessible from within the roof voids. Fully sealed and insulated loft traps should be provided.	£1,000.00

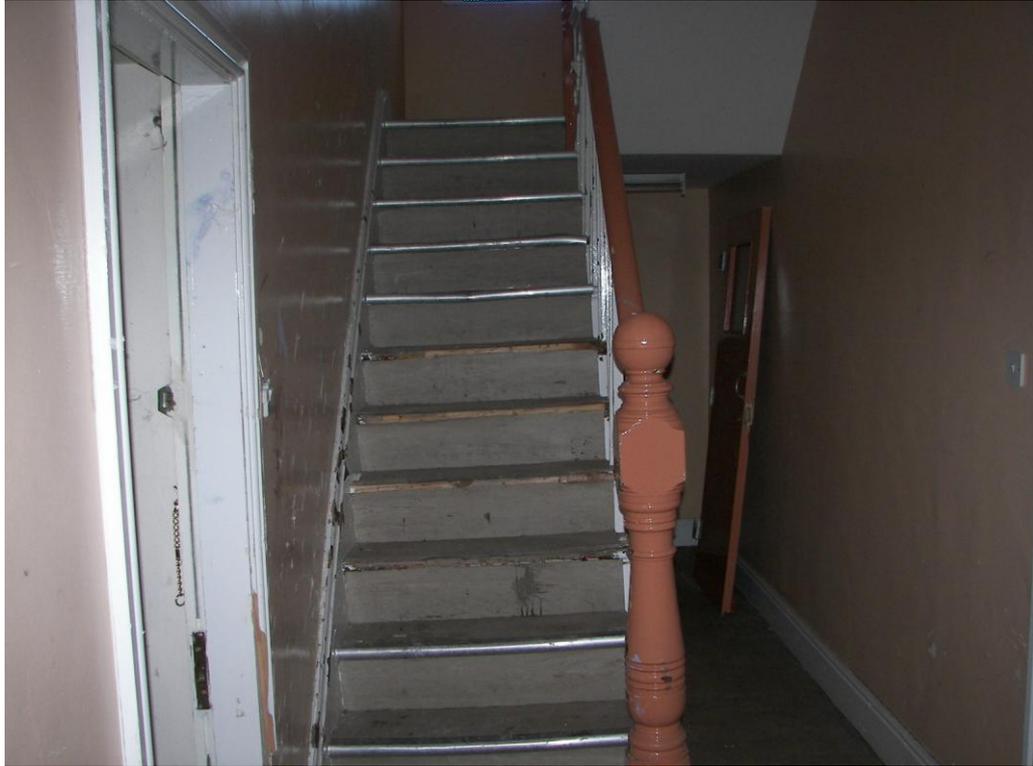
2.16 Structural movement	
2.16.1 To the front elevation there is evidence of downward movement towards the party walls between 6 and 8 Kelvin Grove and between 8 and 10 Kelvin Grove, also apparent internally due to the slightly sloping staircase and floors. We noted a crack at the vertical junction between 8 and 10 Kelvin Grove, and cracking was also visible at the junctions between the front bays and the front elevation. Furthermore, there appears to be a general downward movement towards the rear of the property, the front elevation and bays leaning slightly in that direction. No obvious visible evidence of structural movement was noted to the right hand and rebuilt rear elevations.	-

Evidence of movement to staircase

2.16.2 Having examined other buildings in the locality, there seems to be a widespread issue with foundation movement. However, without ascertaining the precise cause of this mechanism, we are unable to reach a formal conclusion at this stage. It is therefore recommended that some form of ground investigation is instigated including a structural engineer's input, in order to fully determine the reasons for the movement and appropriate remedial measures. At this stage we have allowed a provisional sum for foundation stabilisation.	£60,000.00

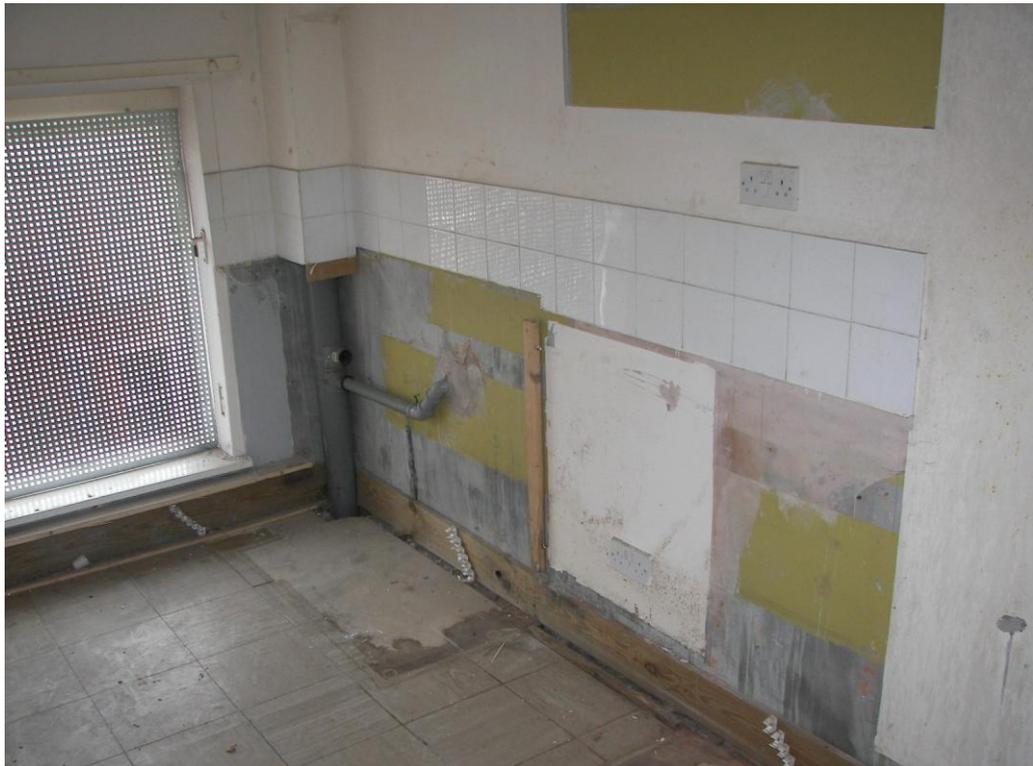
Typical internal condition
