Welsh Streets, Princes Park, Liverpool

Building Survey Report

40 Kelvin Grove

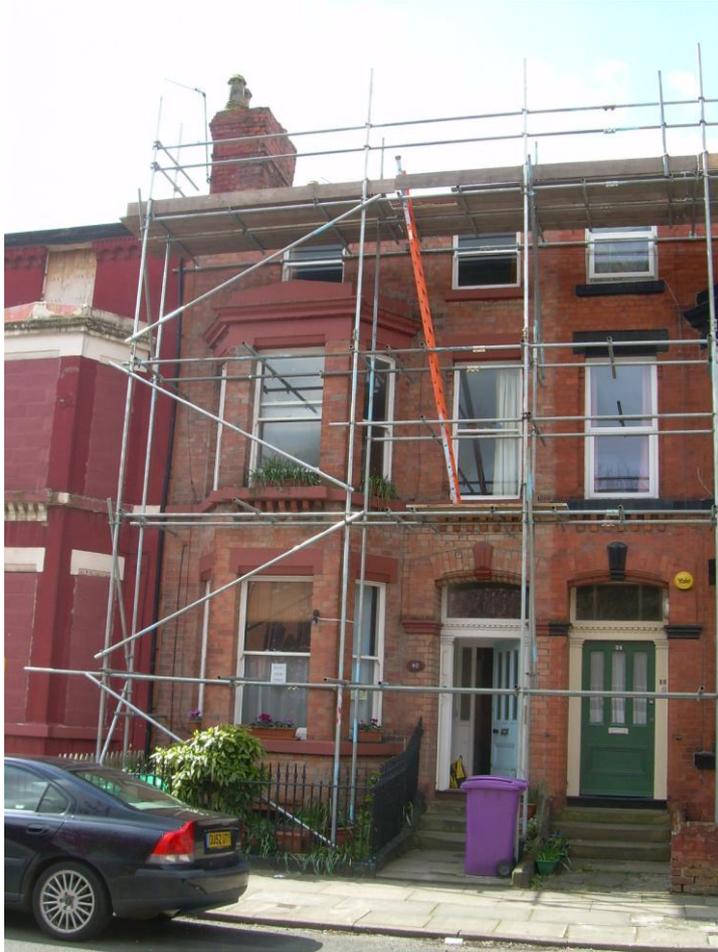
2.2 Elevations	
2.2.1 The front elevation has been re-pointed in the past and is now generally in good order. Local re-pointing is required however, particularly at high and low levels.	£300.00

Front elevation

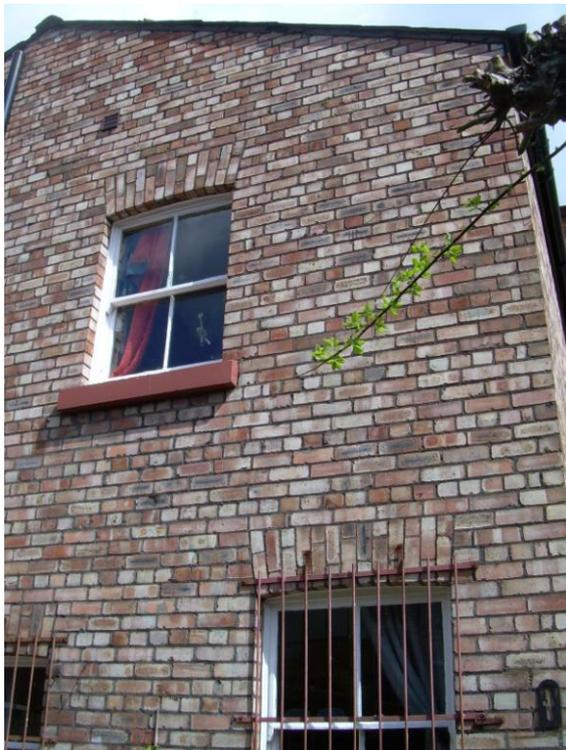
The elevations are of brick masonry construction originally approximately 450mm thickness to the front and rear elevations built in Flemish bond and having ornate eaves mouldings to eaves and below first floor window sills to the front with sandstone sills and lintels generally. However, the outer walls of the rear wing and part of the rear elevation have been re-built as some point c. 50 years ago in solid 340mm brickwork.

Rebuilt rear wing elevation.

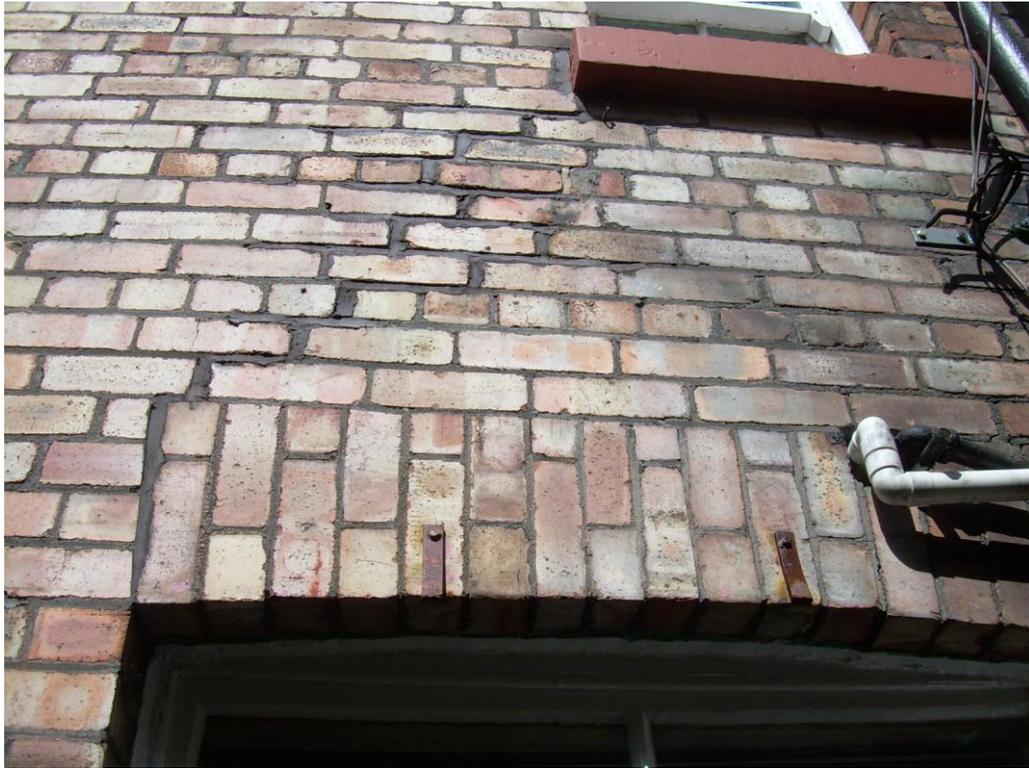
2.2.2 There is some stepped cracking to the rear wing emanating from the ground floor openings in the left hand elevation. As we are aware that some stabilisation works has been undertaken to this property, we have no information as to this movement being progressive. An allowance for crack repair is included.	£500.00

Cracking to rear wing flank wall.

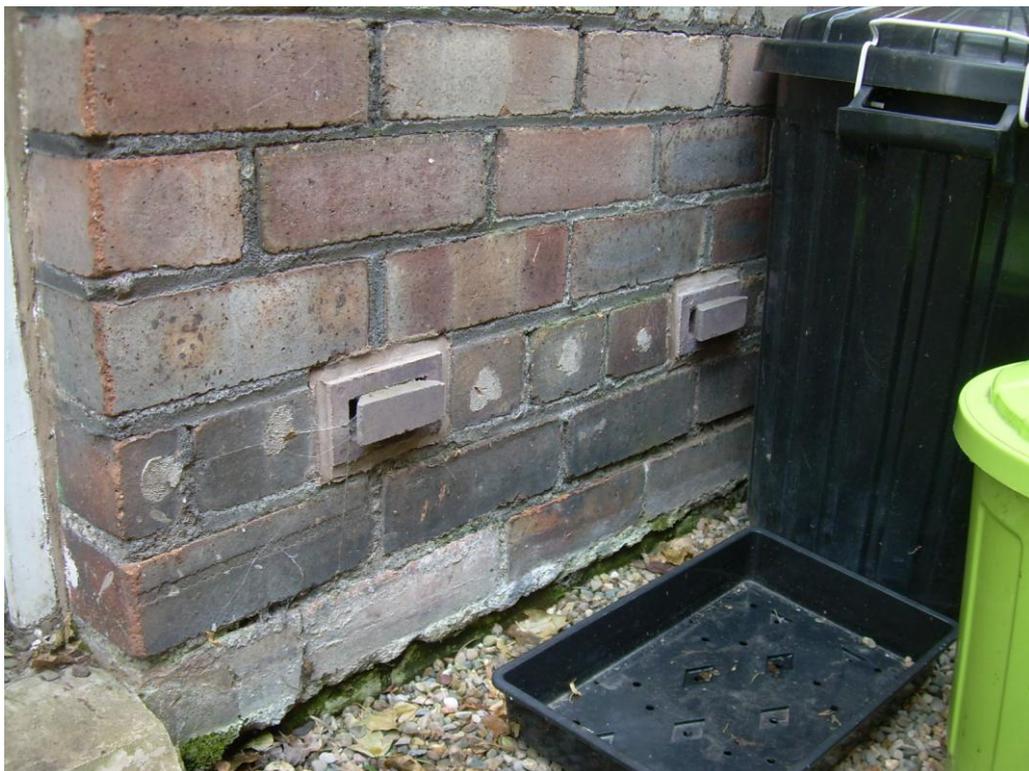
- 2.17.1 Moisture levels within the main house appear largely acceptable. The rear wing however has had both chemical and evaporative damp proof (Shrijver System or similar) systems installed. The works appear largely effective based upon meter readings in timber skirting, other than a localised area in the rear left of the kitchen. £250.00

Shrijver System damp proofing to rear wing.

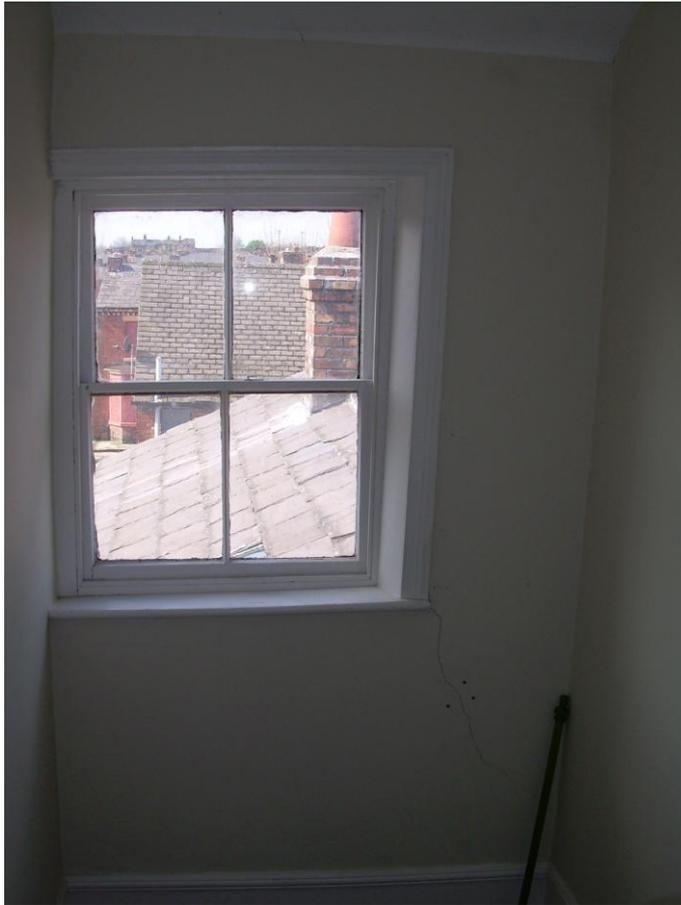
There are areas of cracking in the property, to the rear elevation and left hand party wall which are, we understand under active monitoring by a structural engineer. Access to observations gained would be of benefit.

Cracking with tell-tales beneath rear stairwell window

- 2.16.1 This property (rear wing and rear elevation) has already been treated; we are informed, with a Uretek resin stabilisation system. Further details of this installation and the investigation process undertaken, would be of benefit. £25000.00

We have allowed a provisional sum for foundation stabilisation at this stage, since we have no information as to the success of these works.

- 2.16.2 Having examined other buildings in the locality, there seems to be a widespread issue with foundation movement. However, without ascertaining the precise cause of this mechanism, we are unable to reach a formal conclusion at this stage. It is therefore recommended that some form of ground investigation is instigated including a structural engineer's input, in order to fully determine the reasons for the movement and appropriate remedial measures. -

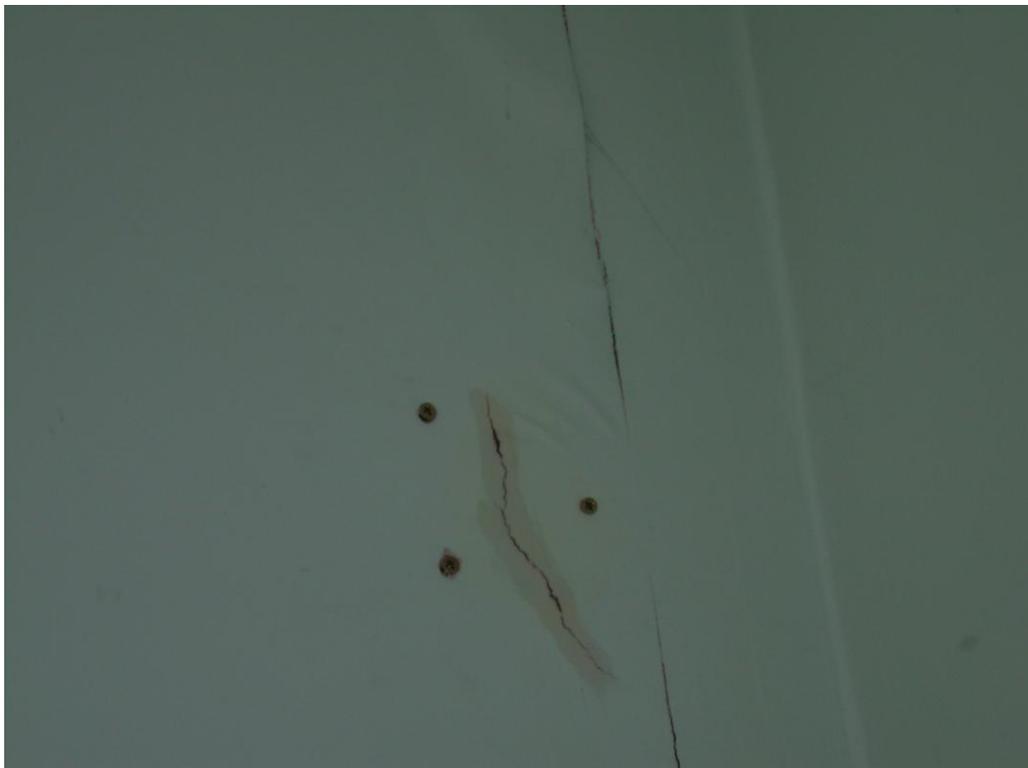
Tell-tale to second floor party wall – party with 42.
