Welsh Streets, Princes Park, Liverpool

Building Survey Report

46 Kelvin Grove

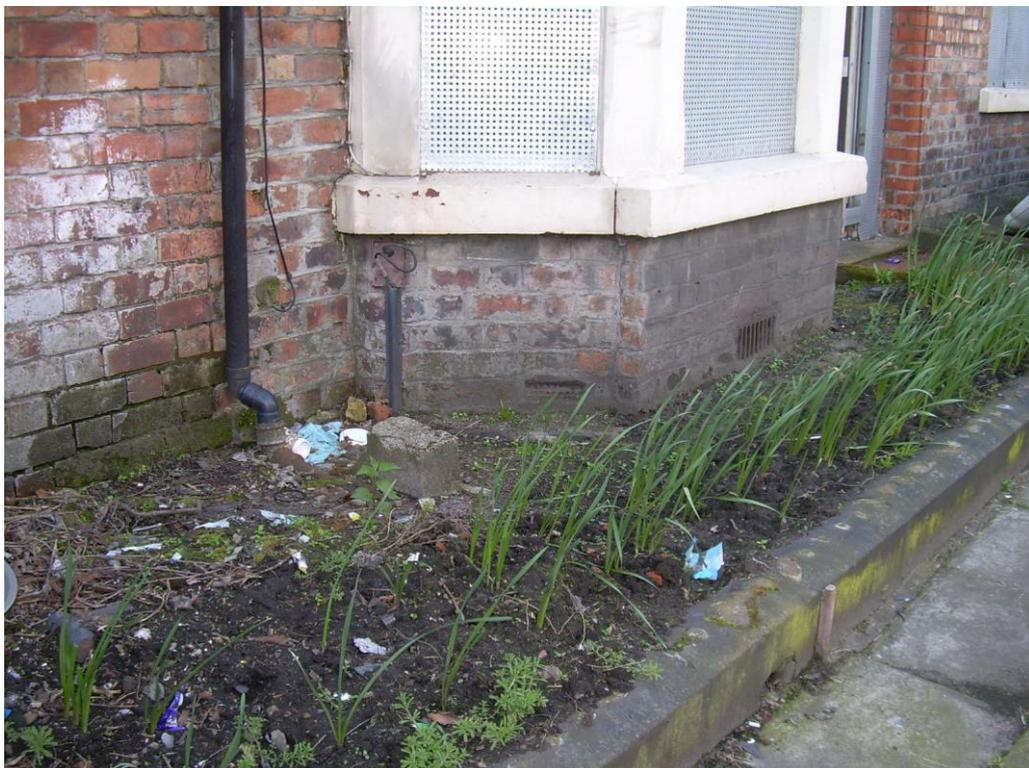
2.3.1	The side yard was not accessible so provisional repairs sum to be included as part of any retention proposal.	£1000.00
2.3.2	The paving to the front yard is a little high and should ideally be isolated from the building elevation to aid drying of the lower fabric to ease dampness.	£1500.00

High ground and paving levels to front – exacerbating dampness.

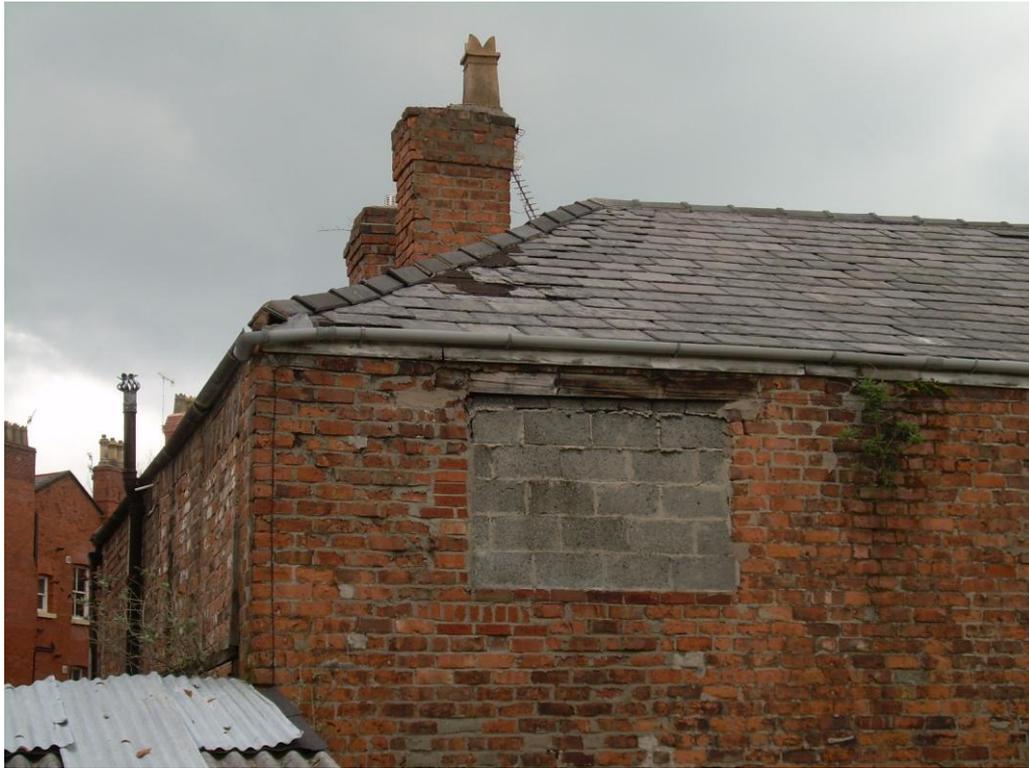
View from rear showing condition beyond demise.

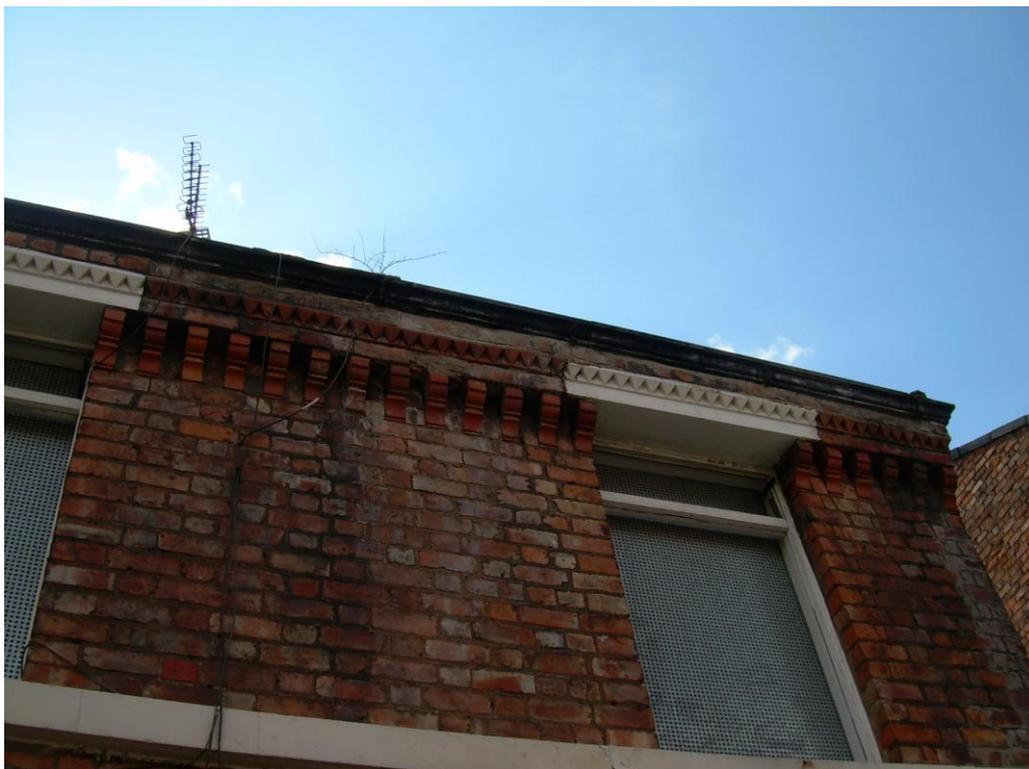
2.1.4	The metal gutters to the front and rear elevations are leaking at joint positions and there are some missing pipework sections, requiring immediate attention by way of replacement to match the existing.	£1500.00

2.2.1	The front elevation has been partially re-pointed in the past and there have been some untidy attempts to repair the dentil course. Sensitive localised repairs are required.	£400.00
2.2.2	Right hand flank elevation not fully visible. Provisional repair quantity to be included.	£500.00
2.2.3	External joinery – generally the casements and sashes are capable of repair but reverting to original window patterns would and sash windows is recommended, incorporating double glazing.	£8800.00
2.2.5	Redecoration of all retained external joinery and stonework is required.	£1000.00

Poor quality previous repair to dentil/ gutter defects.

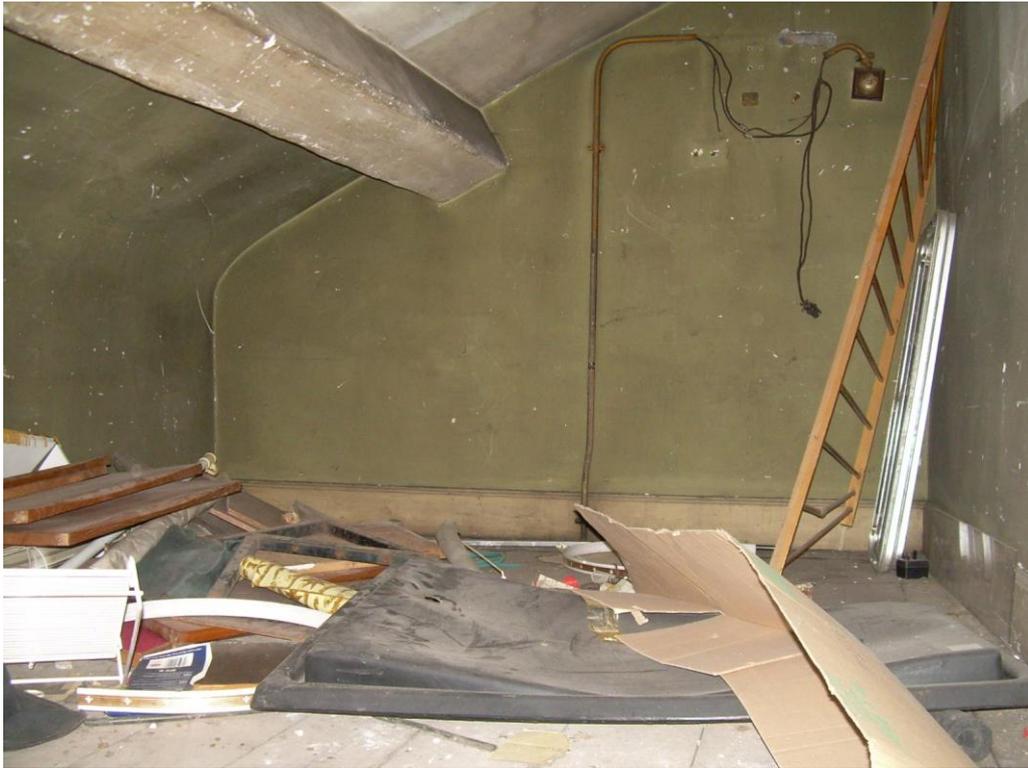
2.4.1	The roof void is only partial and would need to be extended or the ceiling replaced in order to improve insulation levels. Existing conditions in the area, which is plastered and painted, are good. Allowance for access/alteration.	£1000.00
-------	--	----------

Small existing attic space.

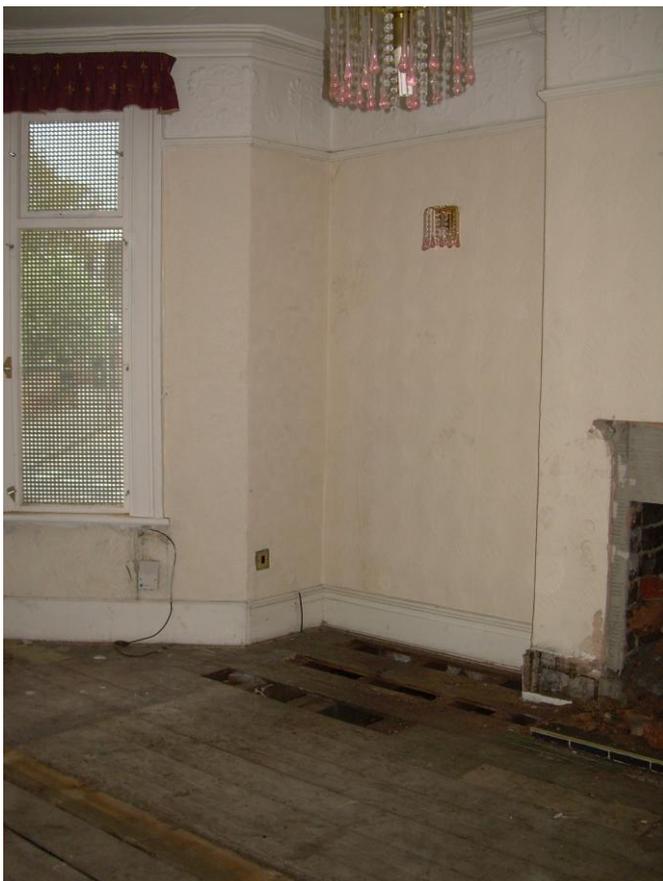
Typical internal conditions.
